Bridge Inspection Report

036-49-03898 AEBL
US 36 EB
over
LITTLE WHITE LICK CREEK

Inspection Date: 03/03/2022

Inspection Type(s): Routine

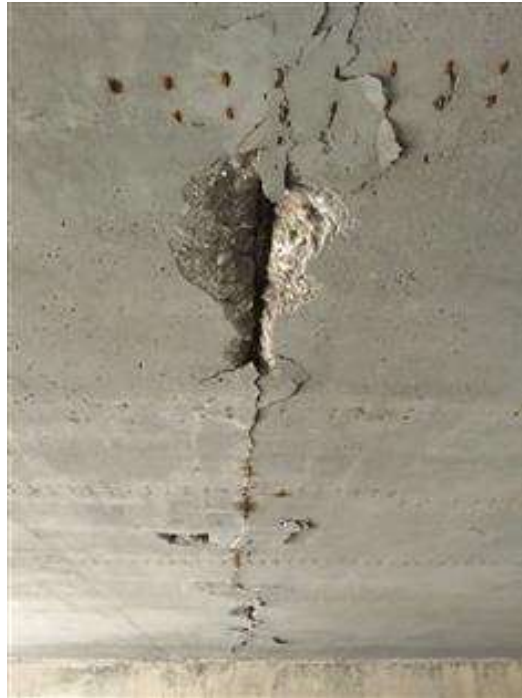
PHOTO 4

End spans - longitudinal cracking near centerline with minor delaminations, rust-staining & efflorescence (36' in span A, 20' in span C) - some spalls due to lack of cover in span C;

Description Span A, cracks, delaminations, spalling

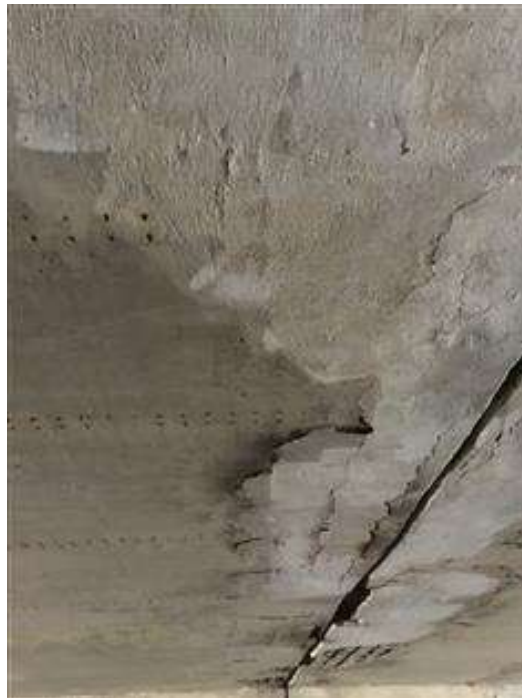
PHOTO 5

Longitudinal joint - repointing, fairly wide longitudinal cracks & delaminations (span A - 33', span B - 38', span C - 36') - 5' spalled w/ rebar exposed span A.

Description Span A center construction joint, delaminating repointing

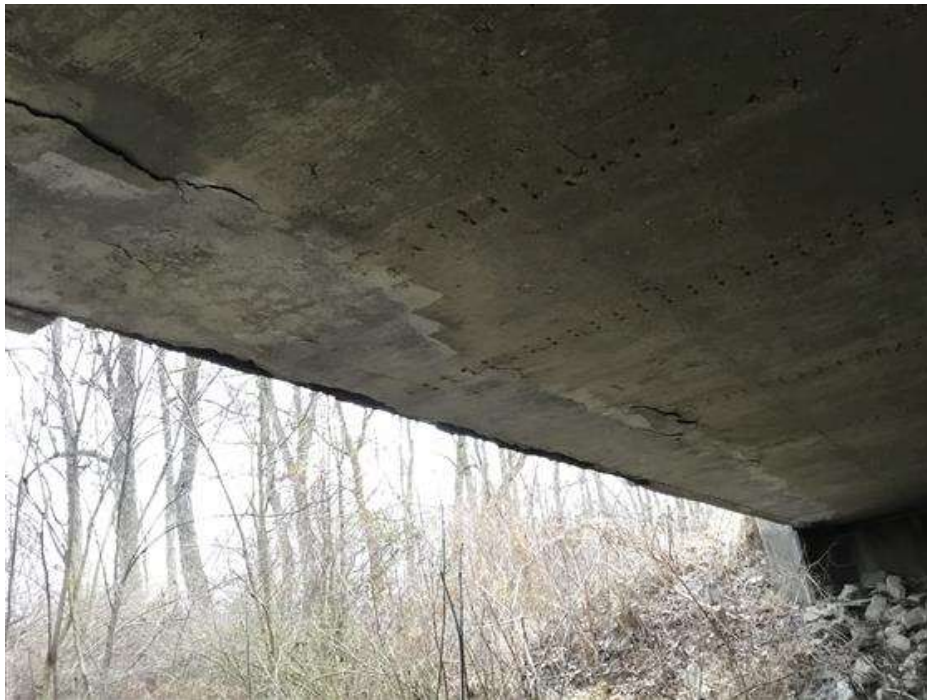
PHOTO 7

South coping - large areas repointed along bottom edge with longitudinal cracks & delaminations (span A - 36', span B - 30', span C - 36') - some areas spalling w/ rebar exposed (10' in span A & 8' in span C);

Description Span A, South coping underside

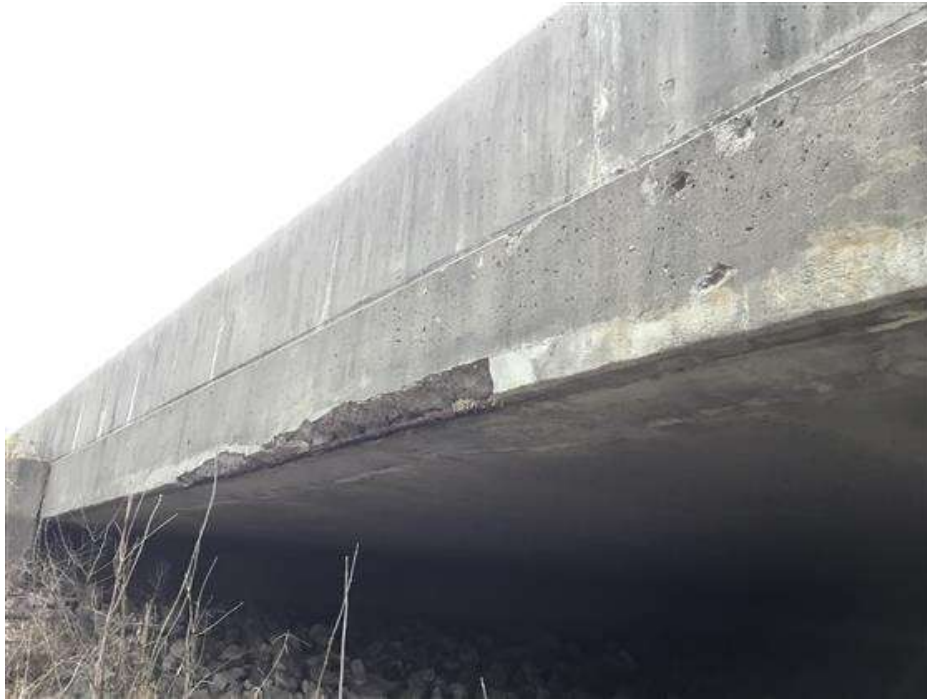
PHOTO 8

Description Span A South coping, cracks, delaminations, spalling

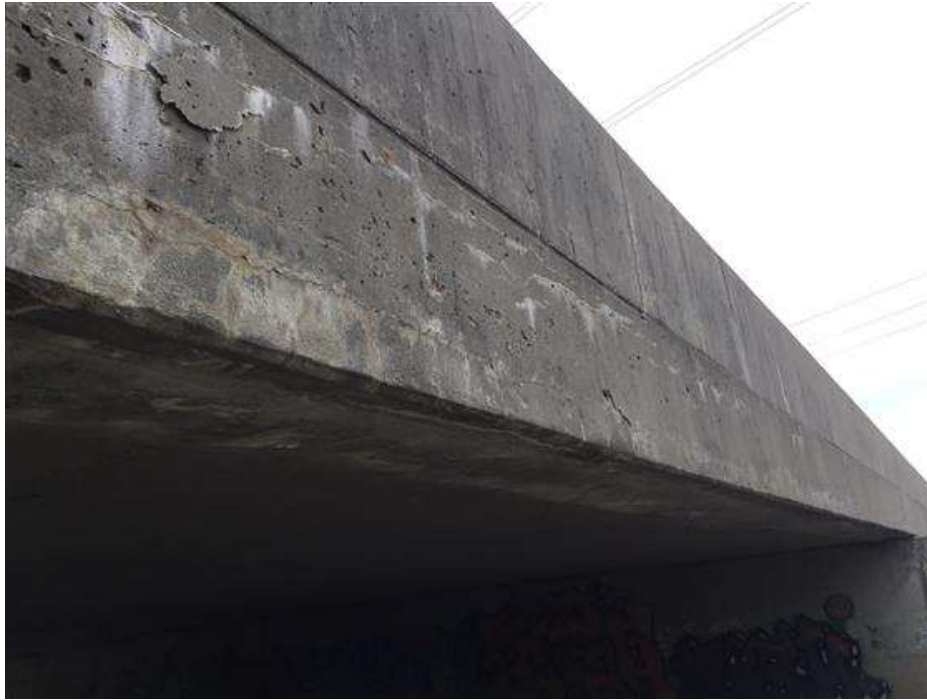
PHOTO 10

Description South coping Span B

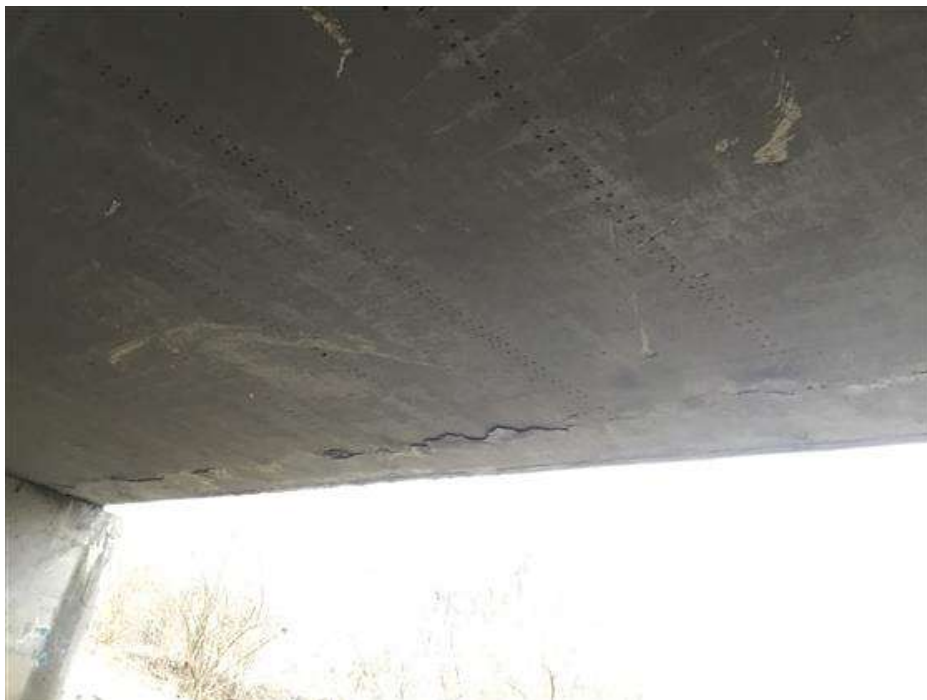
PHOTO 11

Description South coping Span B, underside

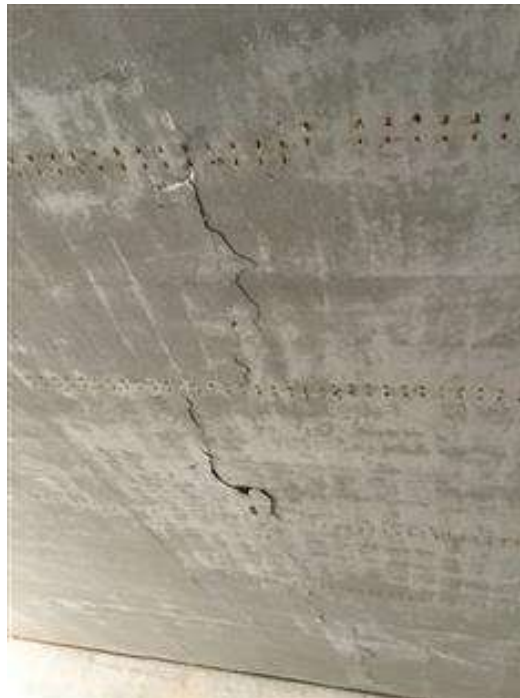
PHOTO 13

Description Span B, cracks, delaminating

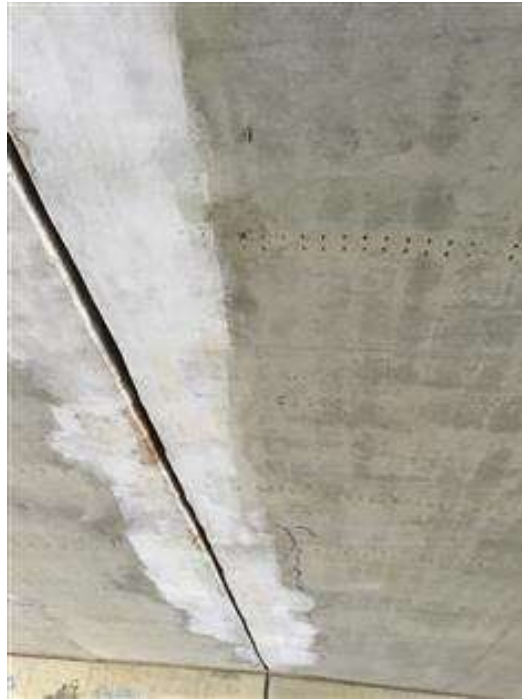
PHOTO 14

Description Center construction joint, repointing, delaminating

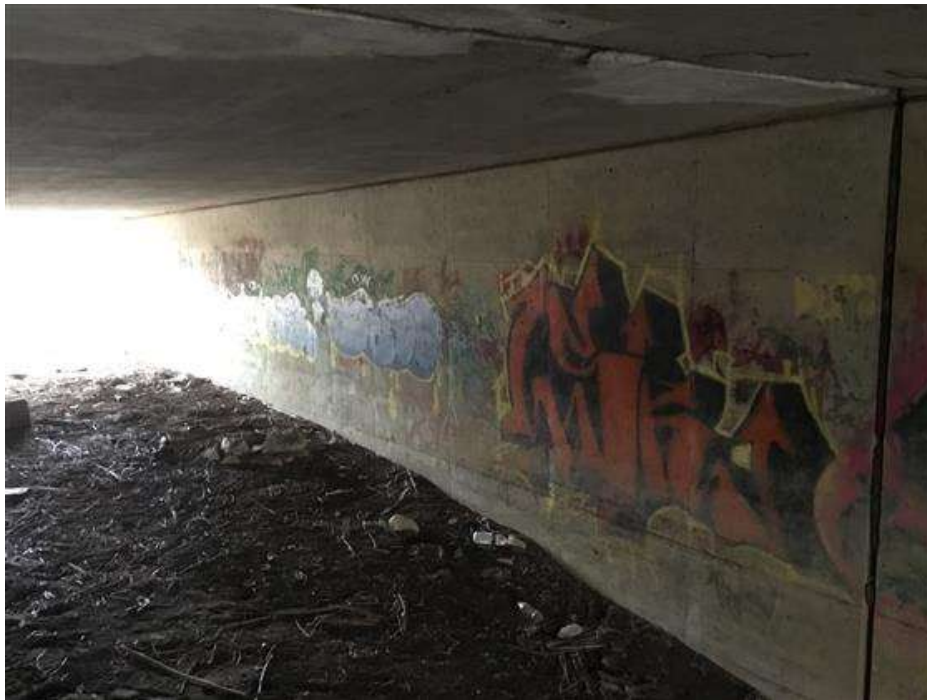
PHOTO 15

Pier stems: minor vertical cracks; repointed area at South end of Pier #3 starting to spall off (1').

Description Pier 3

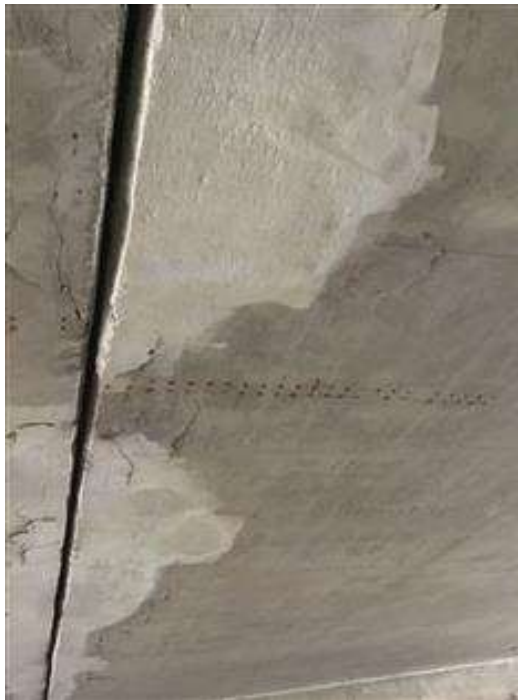
PHOTO 17

Description Center construction joint, delaminating repointing

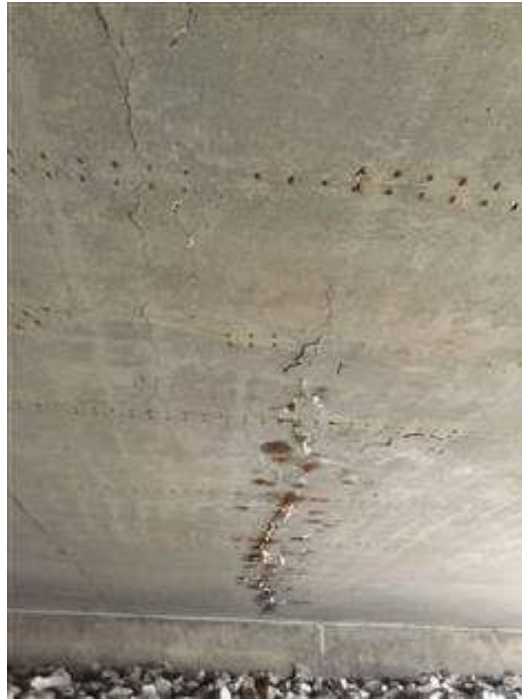
PHOTO 18

Description Span C, cracks, delaminations, rust staining

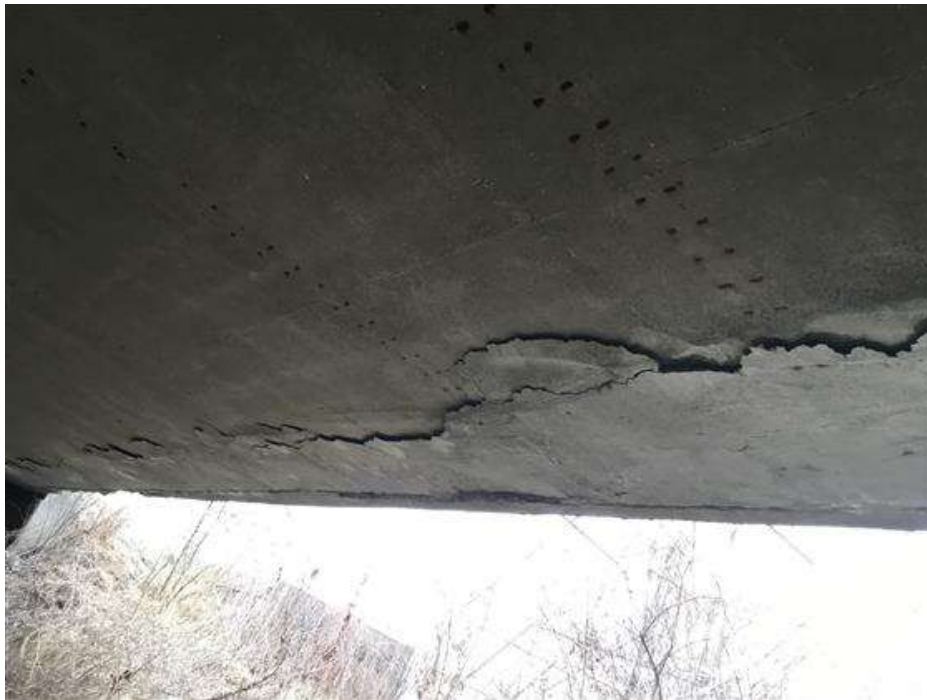
PHOTO 19

Description Span C, South coping, delaminating repointing

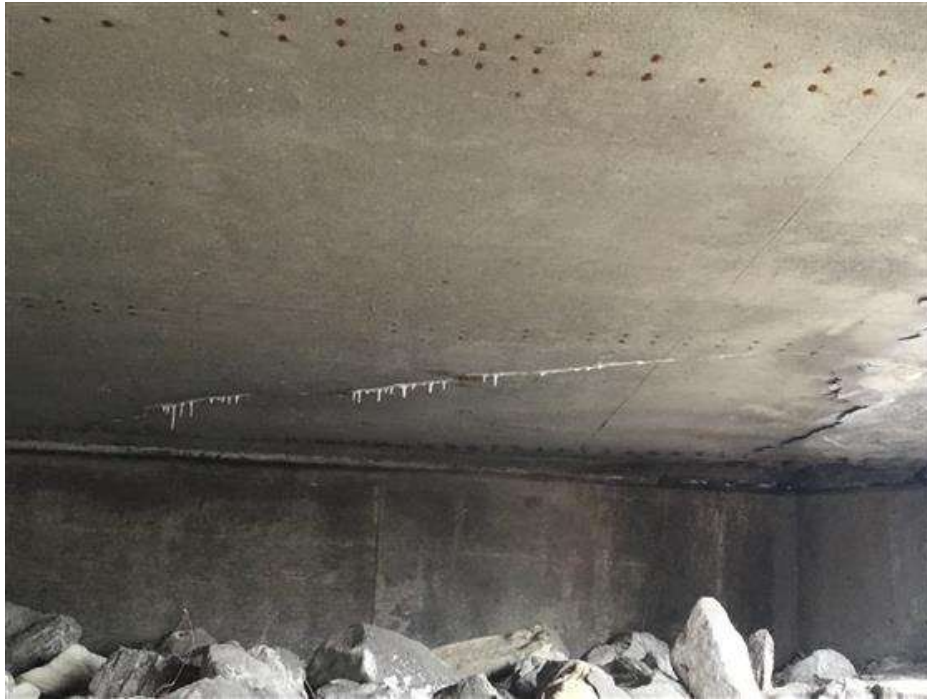
PHOTO 20

Description Span C, cracks with efflorescence, SE corner

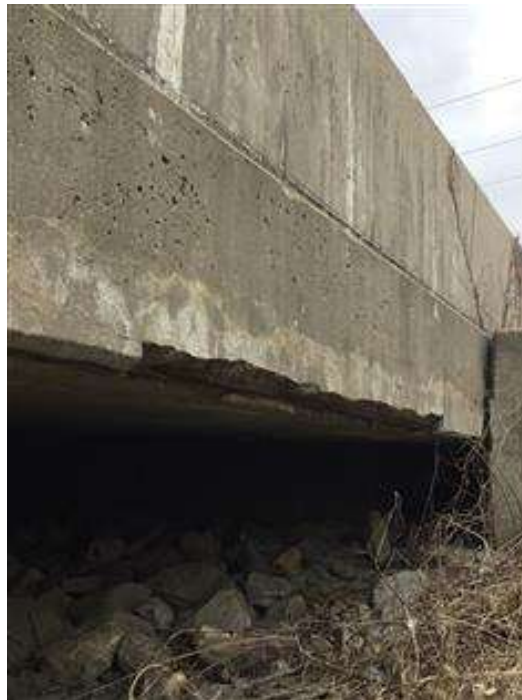
PHOTO 21

Description South coping Span C, spalling

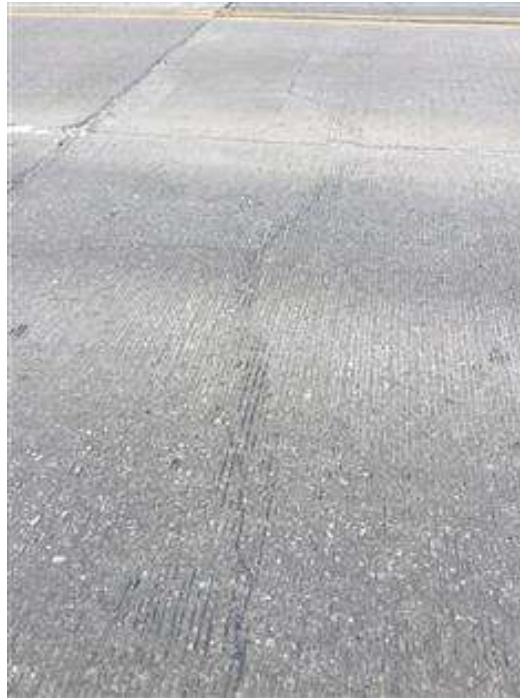
PHOTO 26

Description Cracks East approach slab

Approach slabs: West - fairly wide transverse cracks (25'), small patching at right edgeline (2 SF) & minor spall at right edgeline & end of slab (1 SF); East - fairly wide transverse cracks (25'), triangular patch at right edgeline at IA joint (1 SF).

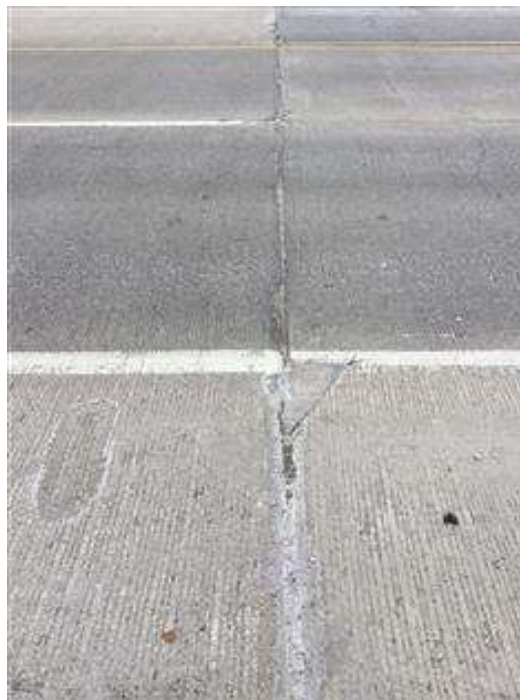
PHOTO 27

Description East joint

Transverse joints type IA: glands mostly gone; minor spalling.

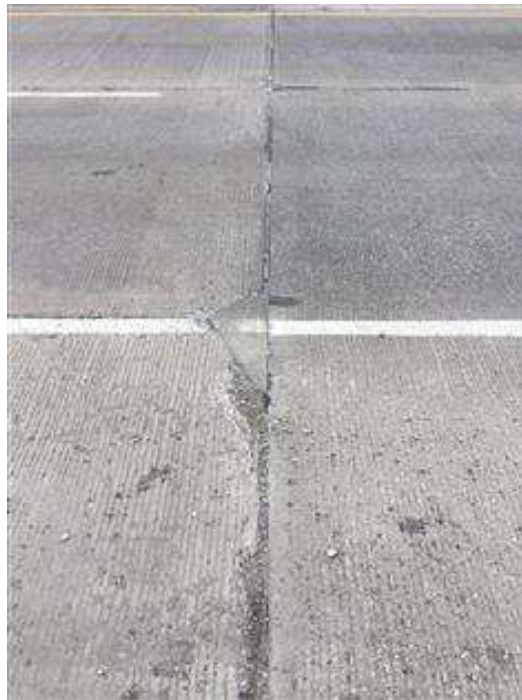
PHOTO 33

Description West joint

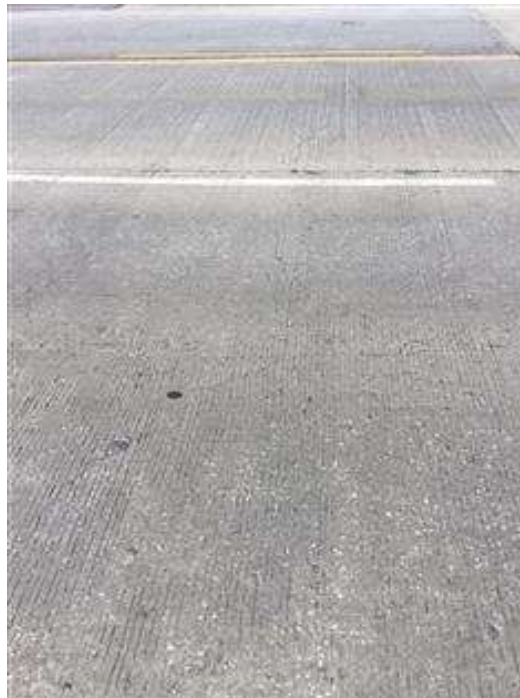
PHOTO 35

Description Cracks West approach slab

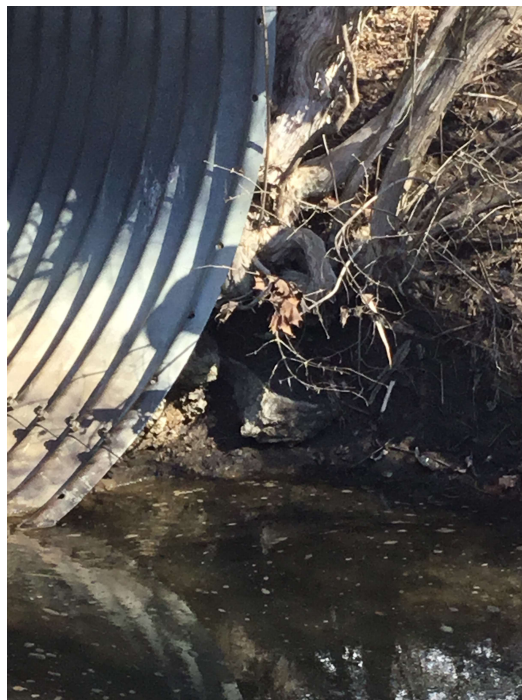
PHOTO 4

Description Missing SE anchor

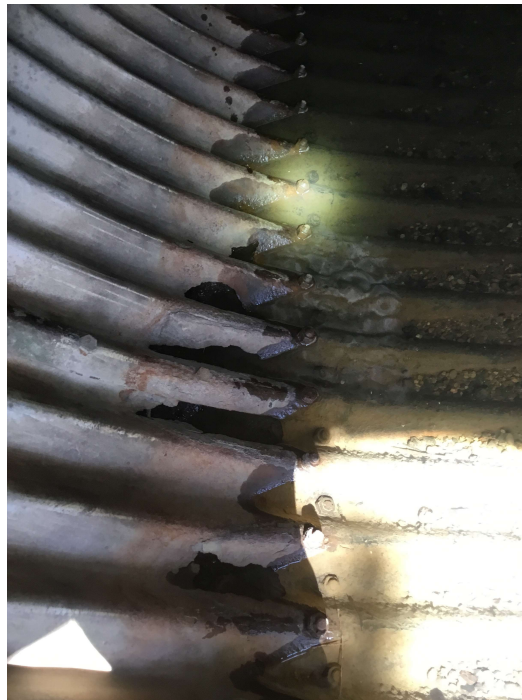
PHOTO 8

Culvert is rated in poor condition because there were a couple of holes that were completely rusted through the pipe approximately 20' into the pipe from the South end. Other than that no noted concerns. There is no approach guardrail. The culvert is about 6' below the road surface. I walked through the culvert during the inspection. The channel runs from the East toward the West. Some scouring on the West end. 5/20/2019

(62) Culvert Rating Comments: *Fairly large rust holes in floor near both ends, heavier at South end. Heavy corrosion at water line throughout the structure with scattered hot spots of corrosion and thinning metal. West side of culvert near the north end has an area of corrosion and rust staining coming from the horizontal seam/bolts. All concrete anchors have very heavy deterioration. Small scour hole at the South outlet.*
Program Year 2023, DES #2002284

Description Large holes near South end
